Manhole Inspection Summary

Manhole # S45E2_036MH

Insp Date: **1/9/08 9:15 AM**

Location Address: **1418 Olmstead St.**

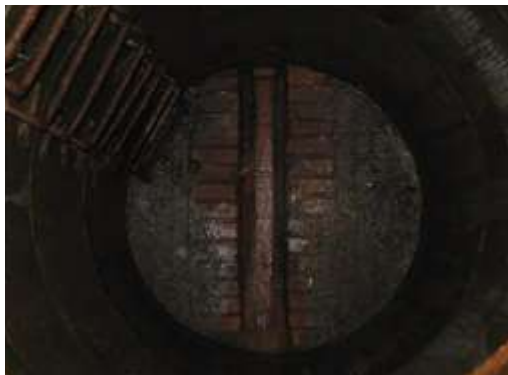
Top View

Comments **The manhole is precast concrete and there is no chimney.**

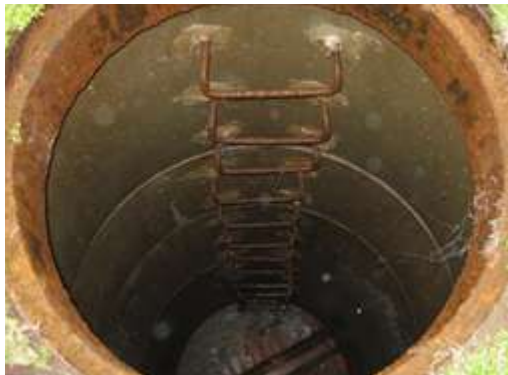
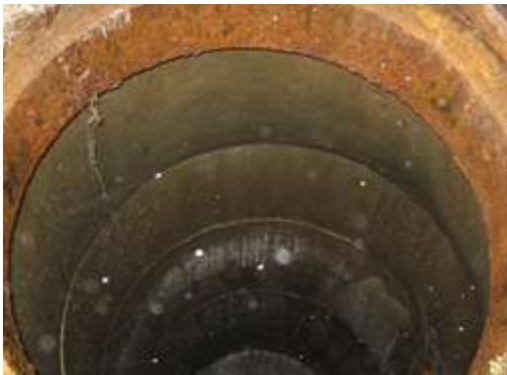
Steps Count: **12** Missing: **0** ☐ Corroded

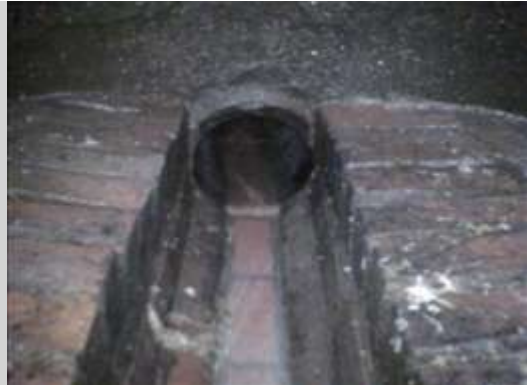
12 O'Clock Outflow

8 in. Circular Gravity Sewer
Pipe Out @ 12 O'Clock

Pipe Height: **10.8** (in.) Rod and Bar (Angled)
Pipe Material: **Clay** ☐ Pipe Lined
Invert Depth: **14.57** (ft.) Flow Characteristics: **Fast**
Deposits: ☒ None ☐ Mud ☐ Sludge ☐ Debris ☐ Grease
Silt Depth: (in.) Deposits Extent:
Infiltration: **None** Pipe Seal Cond: **Sound**

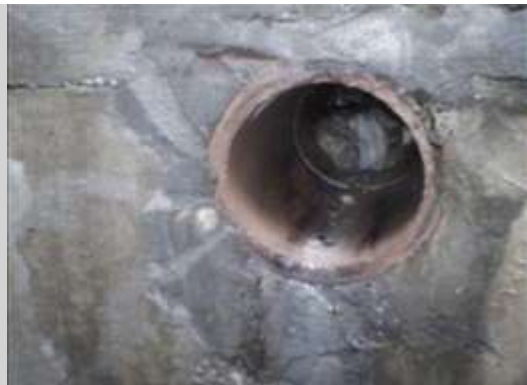
6 O'Clock Inflow

8 in. Circular Gravity Sewer
Pipe In @ 6 O'Clock

Pipe Height: **7.2** (in.) Rod and Bar (Angled)
Pipe Material: **Clay** ☐ Pipe Lined
Invert Depth: **6.66** (ft.) Flow Characteristics: **Fast**
Deposits: ☒ None ☐ Mud ☐ Sludge ☐ Debris ☐ Grease
Silt Depth: (in.) Deposits Extent:
Infiltration: **None** Pipe Seal Cond: **Sound**

Drop: **Outside** Rod and Bar
Angled: **Yes** Reading: **13.20** (ft.)
Inv Depth: **14.20** (ft.)
Drop Condition: **Partly Clogged**
